**DEPARTMENT OF TRANSPORTATION**

Contract #: 04-0120F4Cty: SF/ALA Rte: 80 PM: 13.2/13.9File #: 1x.28**WELDING INSPECTION REPORT****Resident Engineer:**Pursell, Gary**Address:** 333 Burma Road**City:** Oakland, CA 94607**Report No:** WIR-014074**Date Inspected:** 18-May-2010**Project Name:** SAS Superstructure**OSM Arrival Time:** 1230**Prime Contractor:** American Bridge/Fluor Enterprises, a JV**OSM Departure Time:** 1600**Contractor:** American Bridge/Fluor Enterprises, a JV**Location:** Job Site**CWI Name:** Bernard Docena**CWI Present:** Yes No**Inspected CWI report:** Yes No N/A**Rod Oven in Use:** Yes No N/A**Electrode to specification:** Yes No N/A**Weld Procedures Followed:** Yes No N/A**Qualified Welders:** Yes No N/A**Verified Joint Fit-up:** Yes No N/A**Approved Drawings:** Yes No N/A**Approved WPS:** Yes No N/A**Delayed / Cancelled:** Yes No N/A**Bridge No:** 34-0006**Component:** OBG Sections**Summary of Items Observed:**

## WELDING INSPECTION REPORT

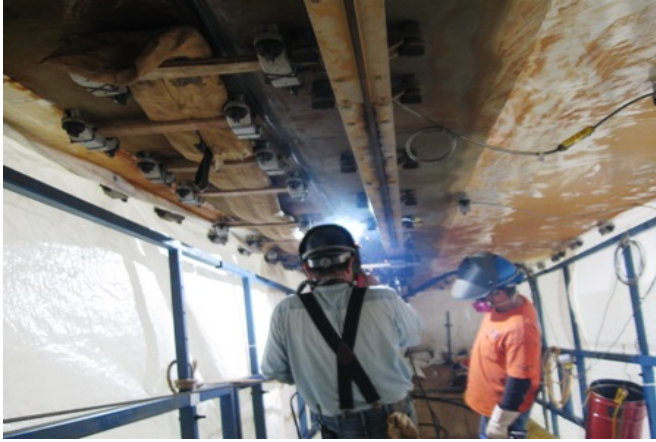
At weld joint W1/W2 – C1 and C2 this QA Inspector ABF welding personnel Rory Hogan (#3186) was performing Flux Cored Arc Welding (FCAW) from the outside of the OBG section after back gouging and grinding. See photo below. This QA Inspector observed ABF welding personnel Rory Hogan (#3186) was ready to start welding and did so without a QC Inspector present. The extent of welding was a single pass approximately 2,000 mm in length. This QA Inspector performed a random verification of the following welding parameters; 235 amperes and 20.5 volts at a travel speed of 180 mm per minute. After completion of this weld pass QC Inspector Bernard Docena arrived at this location to monitor the welding. This QA Inspector previously observed QC Inspector Bernard Docena was present at W2/W3-C1 inside the OBG where QA Inspector Jojo Lizardo was present monitoring welding and QC functions. This QA Inspector asked QC Inspector Bernard Docena if he was covering both locations at the same time (inside and outside the OBG sections) and was informed that he currently was. This QA Inspector asked QC Inspector Bernard Docena if he aware QC personnel needed to monitor welding operations at a frequency whereas there is not a lapse of greater than 30 minutes. QC Inspector Bernard Docena stated he was aware of this requirement, that they (QC) were short handed at this time and that he felt he cover both locations within the required lapses in time.

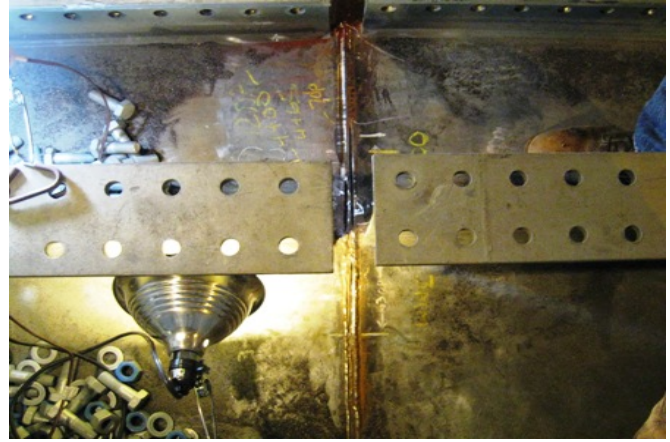
At weld joint E4/E4 – C2 this QA Inspector observed ABF welding personnel Mitch Sittinger (#0315) was in the process of excavating multiple weld repairs. This QA Inspector observed the following: two excavations parallel to each other; one several mm from the toe of the weld and the other towards the opposite toe of the weld, multiple single excavations started running parallel to the longitudinal axis of the weld. The total repair area was 600 mm in length and located 600 mm up from the same “D” (bottom plate) weld. See photo below. The QA Inspector observed the excavations had been done started with a grinder.
